Private Vehicle Inspection Report

Inspection Result: **PASS**

VIN: WAUWFBFH6BN010424

Make: AUDI

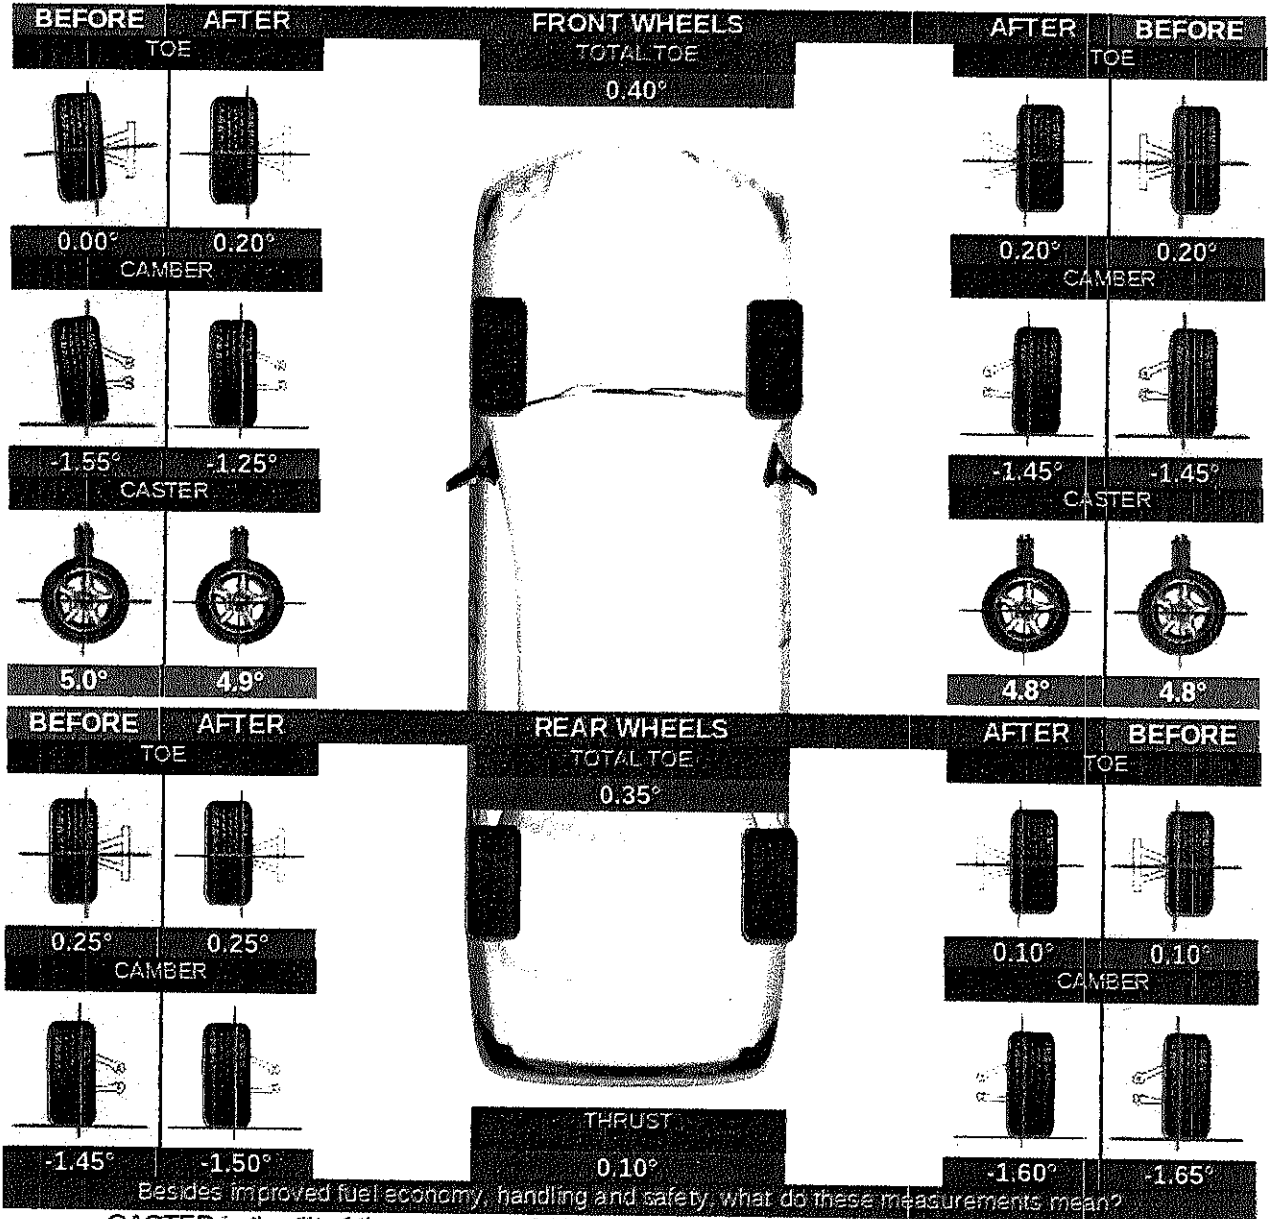
Vehicle AUDI 2011 A5 [8T/8F] Cabriolet [8F] (1BL)
