1C4AJWBG7FL517916 [2024-11-28 - BY DARRIN B.]

Vehicle Details

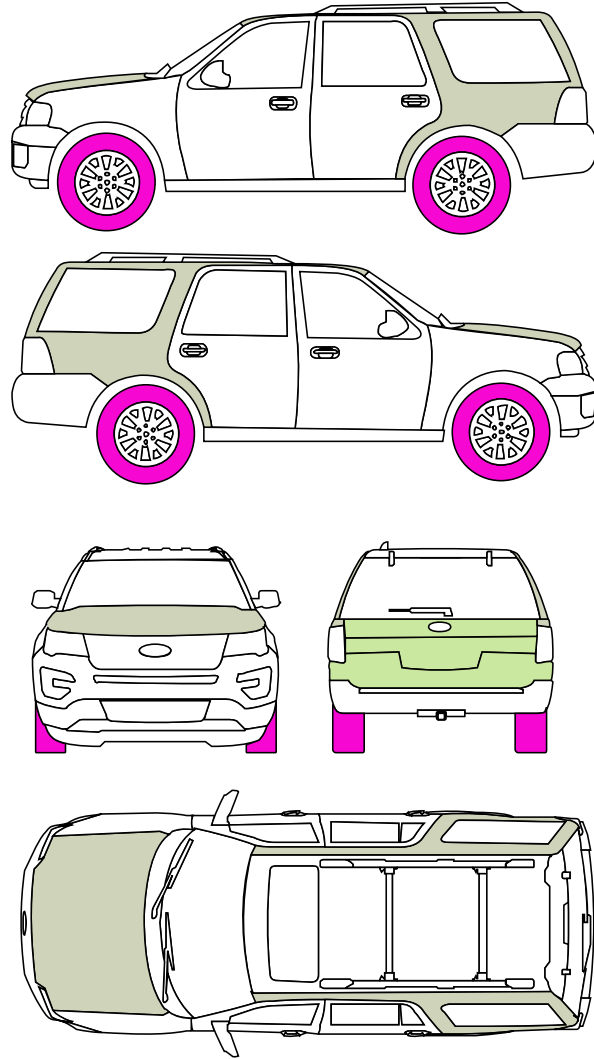
Condition Map

Enviro Paint Damage
Tread Depth
Heavy Scratch
Chipped

Part	Damage	Description	Images
Hood	<ul style="list-style-type: none"> enviro paint damage 	<ul style="list-style-type: none"> 12 inches

<p>Nov 1 2024</p>
Left Front Tire	<ul style="list-style-type: none"> tread depth 	<ul style="list-style-type: none"> 2 mm 	
Left Qtr Panel	<ul style="list-style-type: none"> enviro paint damage 	<ul style="list-style-type: none"> 12 inches

Nov 1 2024
Left Rear Tire	<ul style="list-style-type: none"> tread depth 	<ul style="list-style-type: none"> 5 mm 	
Right Bed Side	<ul style="list-style-type: none"> heavy scratch 	<ul style="list-style-type: none"> 12 inches

Nov 1 2024
Right Front Tire	<ul style="list-style-type: none"> tread depth 	<ul style="list-style-type: none"> 3 mm 	
Right Qtr Panel	<ul style="list-style-type: none"> enviro paint damage 	<ul style="list-style-type: none"> 12 inches

Nov 1 2024
Right Rear Tire	<ul style="list-style-type: none"> tread depth 	<ul style="list-style-type: none"> 4 mm 	
Tailgate	<ul style="list-style-type: none"> chipped 	<ul style="list-style-type: none"> 1
